## PERFORMANCE OF SPRAYED POLYURETHANE FOAM ON INDOOR FOUNDATION WALLS

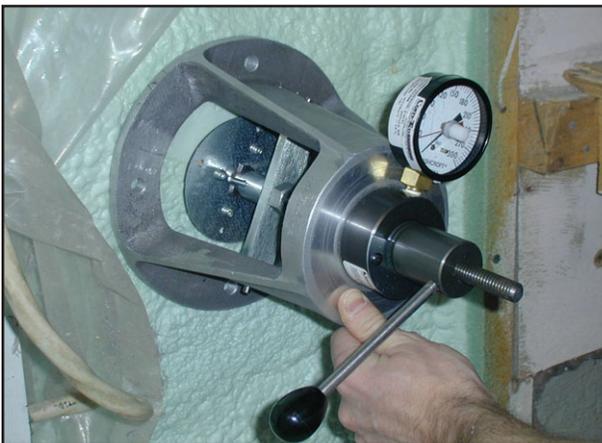
The device used displayed a reading on a dial, expressed in kg, of the tear strength force required to detach the insulation from the foundation wall.

Before the tests, a researcher knocked on all the accessible, insulated wall surfaces to check whether there might be any cavities behind the insulation and to determine the location of the adhesion test sites.

Adhesion tests were performed with a specialized instrument to ascertain whether the insulation provided acceptable adhesion to the foundation over time. To do so, two to four tests were performed in each house, at strategic sites:
